| Document number | SUPAIR_2016/06_002 |

## SAFETY WARNING

**SUBJECT :** Chest strap's Safe-T buckle  
inadvertently opening in flight

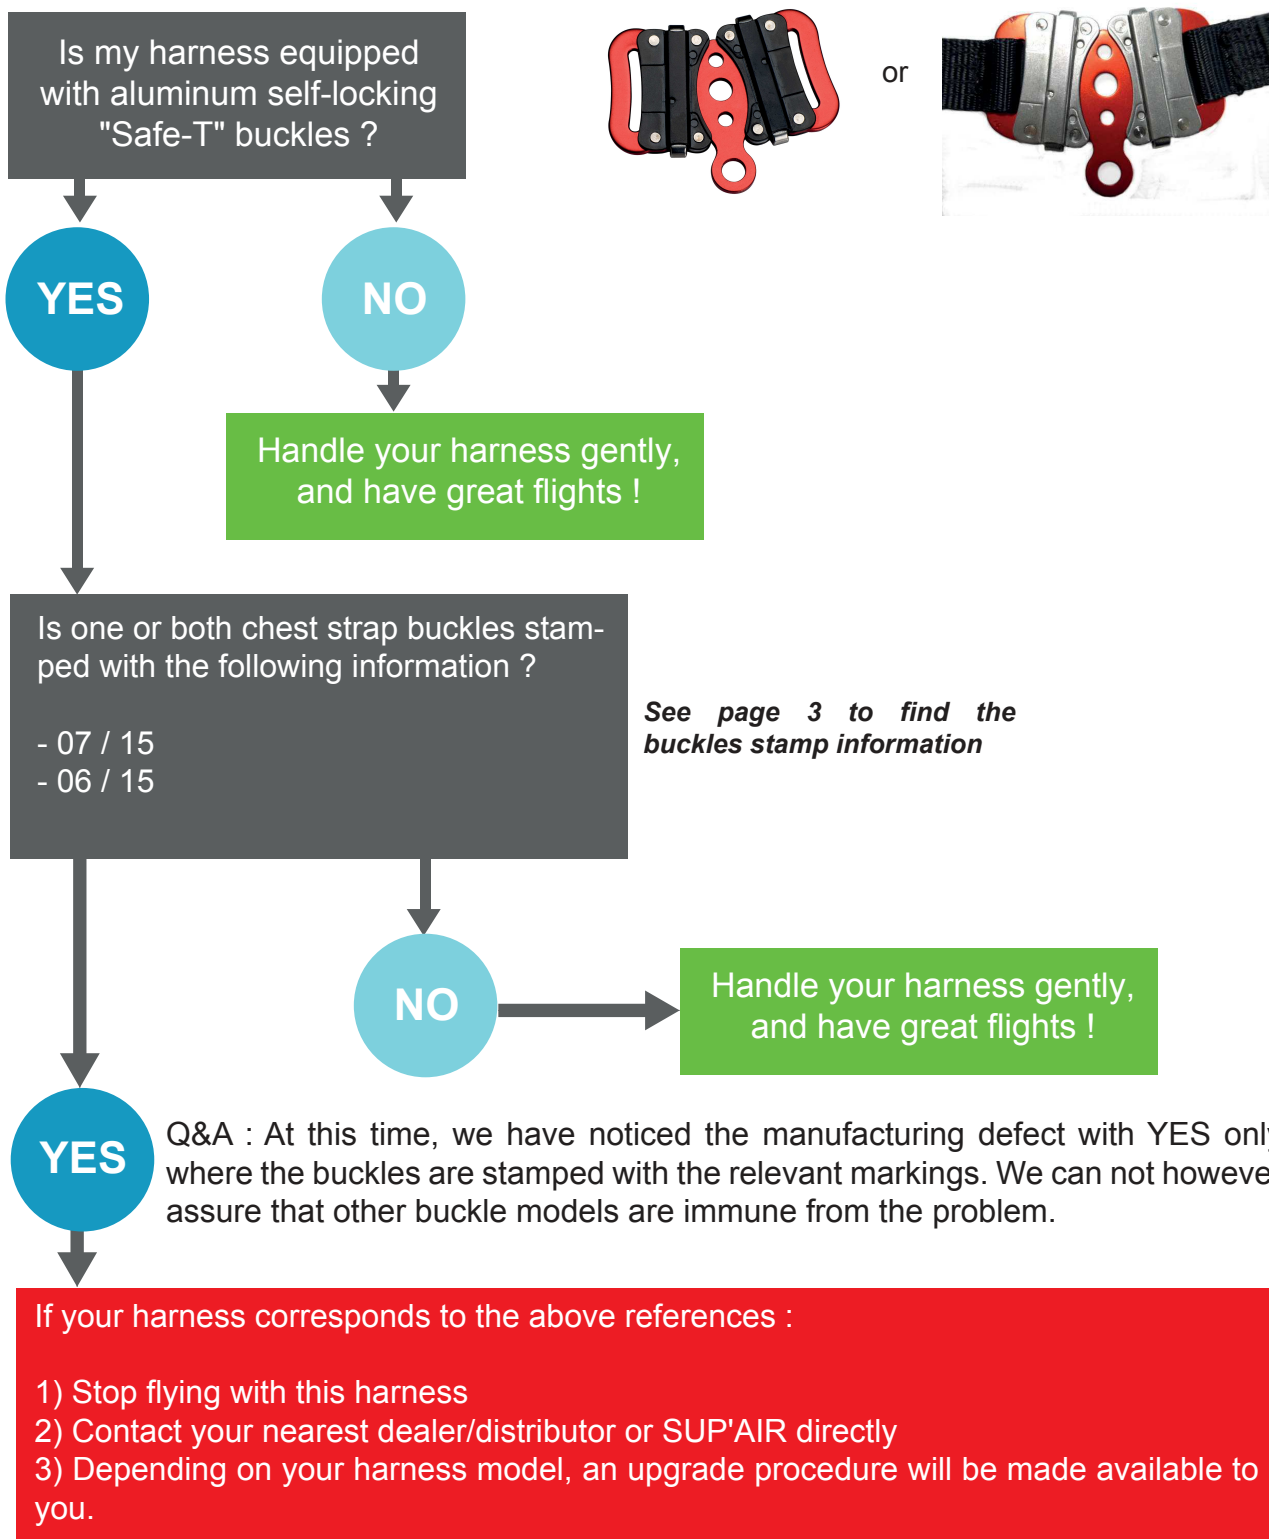
*How to identify if my harness is concerned ?*

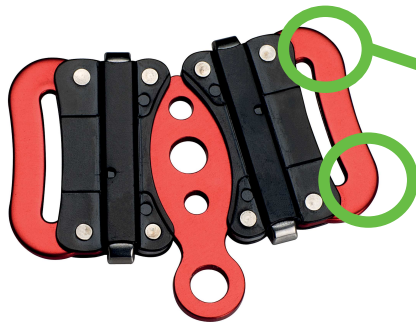
### Where to find the self-locking buckles stamp information ?

Example :

06 / 15

RQ : If the stamped information is not visible, please contact us !
